LANDMARK CORPORATION

Structural Review Update Thompson Community Center Gymnasium Concrete Masonry Unit (CMU) Walls

January 27, 2023

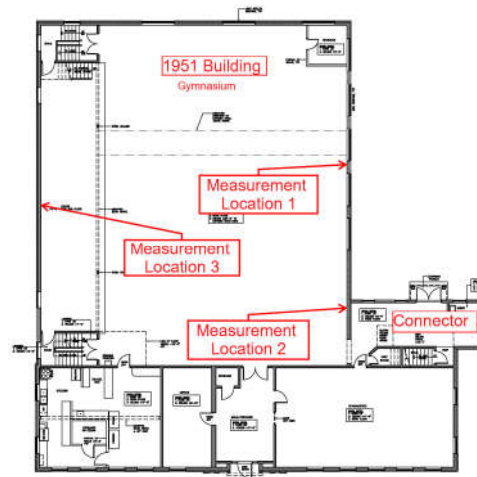
Measurement Key

Location 1	
North Wall (26' from west wall)	
Height(ft)	Displacement (in)
0	1-1/4
4	1-7/8
8	2-1/8
12	2-3/16
16	2
20	1-3/8
22	0

Location 2	
North Wall (8' from front corner)	
Height(ft)	Displacement (in)
0	5/16
4	3/8
8	1/4
12	1/4
16	1/4
20	3/16
22	0

Location 3	
South Wall (center stage)	
Height(ft)	Displacement (in)
4	2-1/8
8	2-1/2
12	2-3/4
16	2-1/2
20	1-3/8
22	0

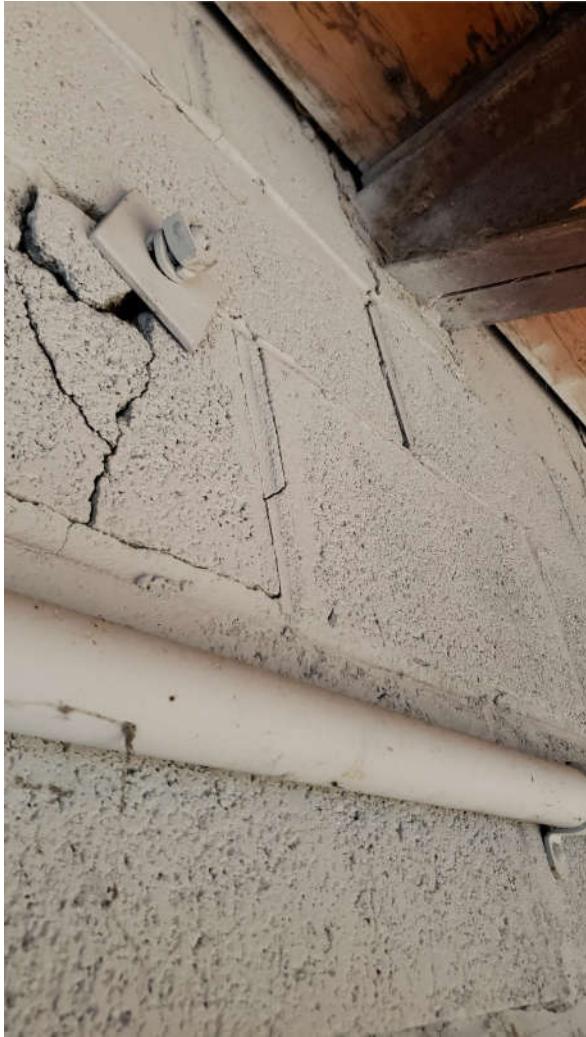
Location 1 – Although the maximum displacement measured at Location 1 on the North Wall is greater than previously reported (2-3/16" compared to 3/4") we have concluded that this can be attributed to more accurate measurements, especially at the top of the wall. As can be seen in comparison Photos 1 and 2, the cracking at Location 1 has not become worse in the 4.5 years since our initial inspection. Of note, is the significant amount of deflection that occurs in the top 6' of the wall. Some of this may have been built into the original wall, however the cracking is a sure sign of past movement (see Photo 3 and Photo 4).

Photo 1 – Crack on North wall 2023

Based on the above findings, we can conclude that the displacement of the gymnasium load bearing CMU walls has not become substantially worse. However, the current condition and lack of water intrusion maintenance at window and door openings is not conducive to long term stability. The walls are in a stressed state, and the prior conclusion of "substantial structural damage" remain. We continue to recommend that these walls be braced or be rebuilt to resist further movement and accommodate current loading standards.

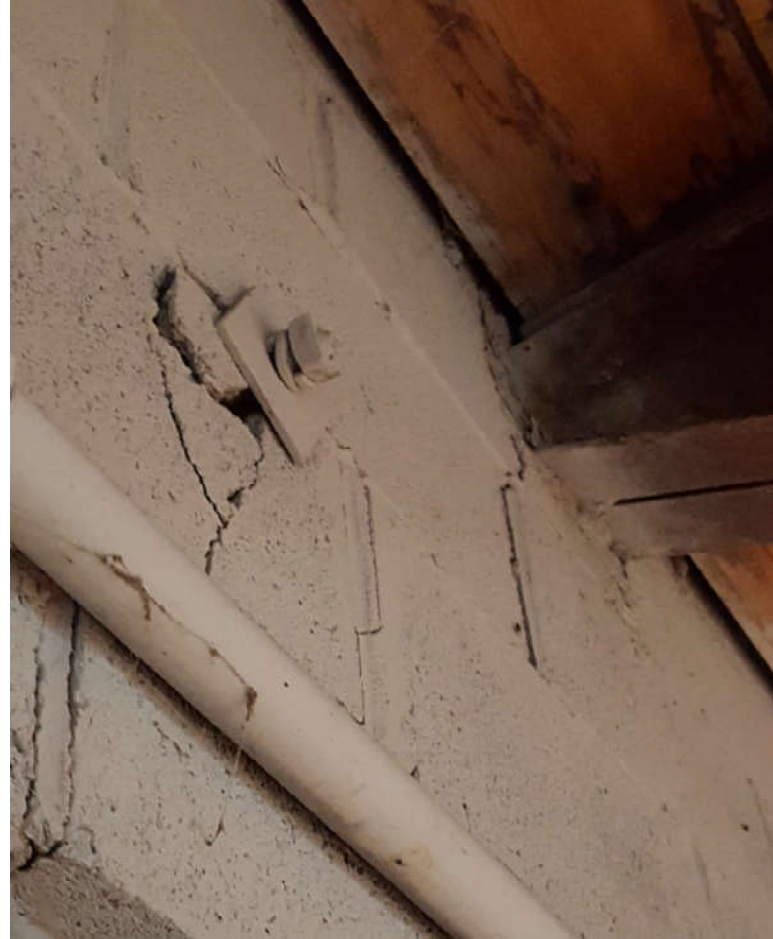
Photo 2 – Crack on North wall 2021

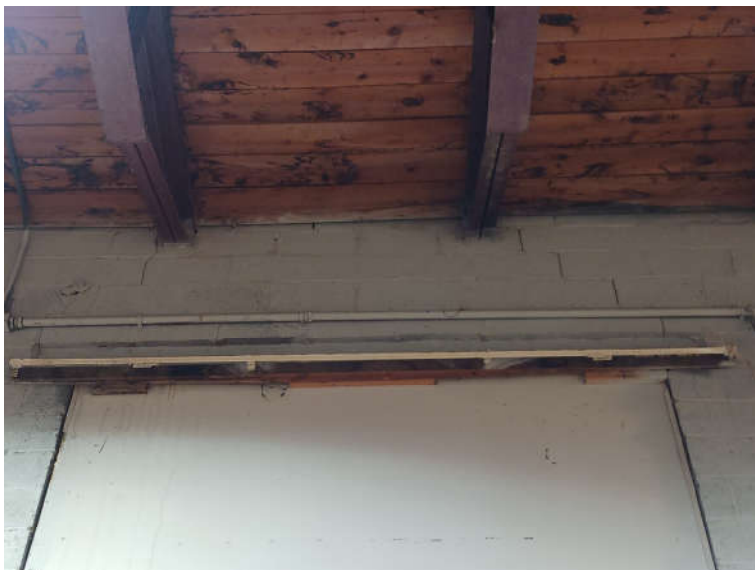
Photo 3 – North wall cracks 2023

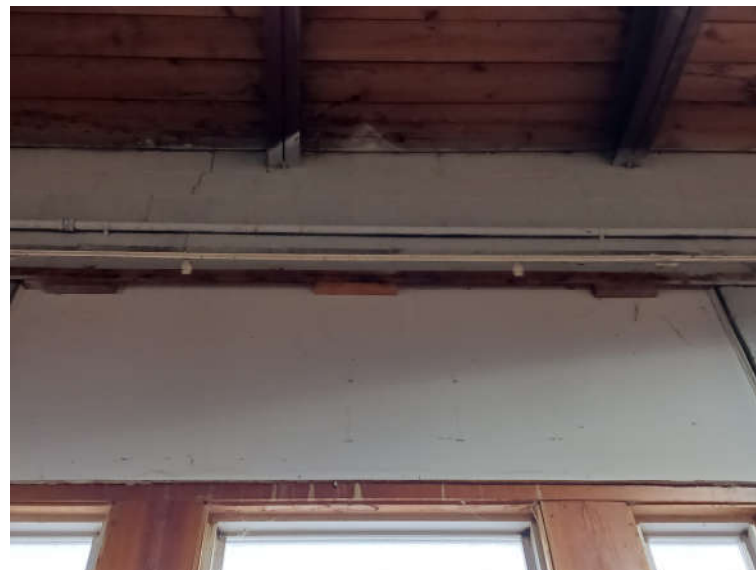
Photo 4 – North wall cracks 2023

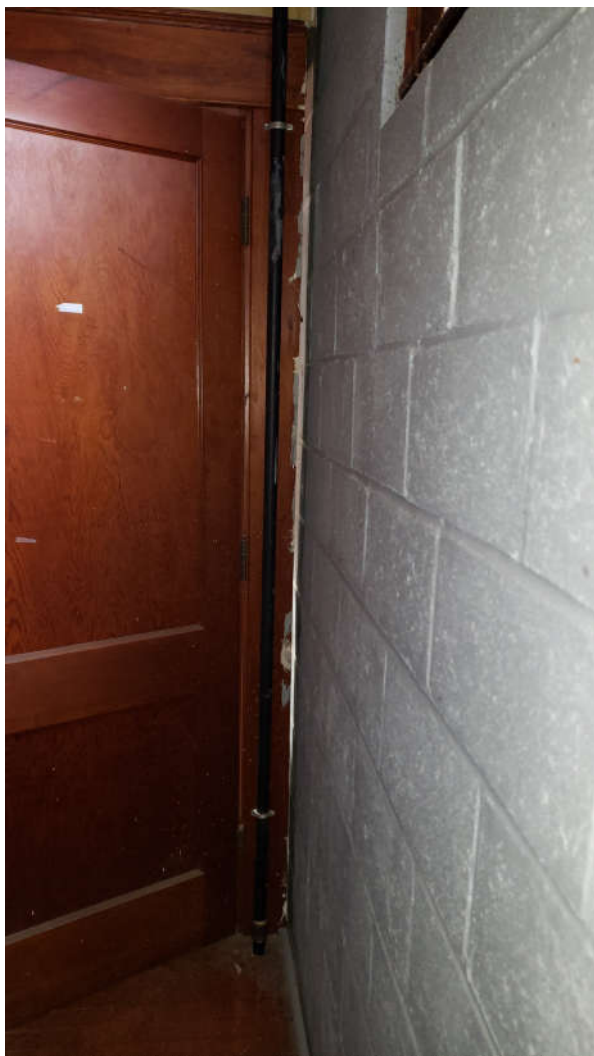
Location 3 – The maximum deflection at Location 3 is similar to previously measured (2-3/4" compared to 3"), the difference can be attributed to a slightly different measurement location or increased accuracy. Similar to the North wall, the South wall cracking and/or movement has not become worse, see comparison Photos 5 & 6 and Photos 7 & 8. Also, like the North wall, the South wall has a large amount of deflection in the top 6'.

Photo 5 – Displacement at door 2023

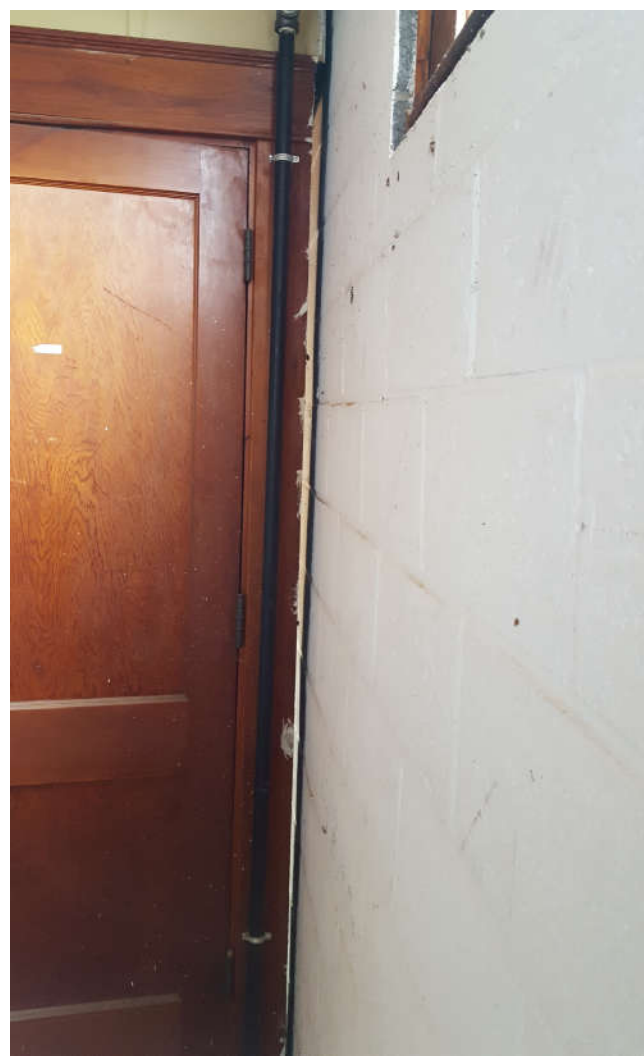
Photo 6 – Displacement at door 2018

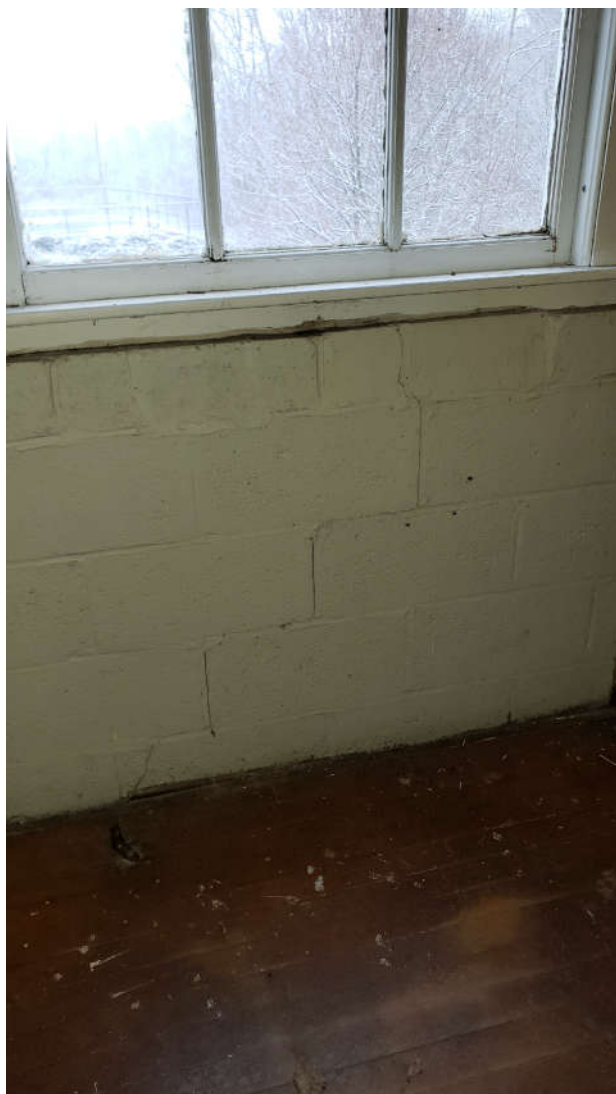
Photo 7 – Cracking at stairwell window 2023

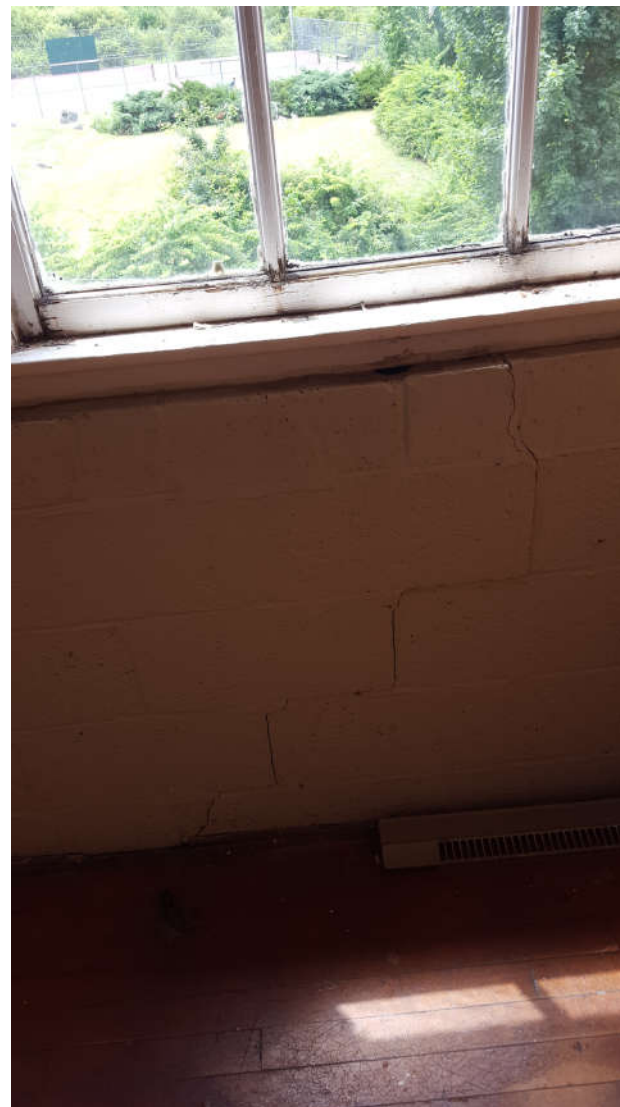
Photo 8 – Cracking at stairwell window 2018

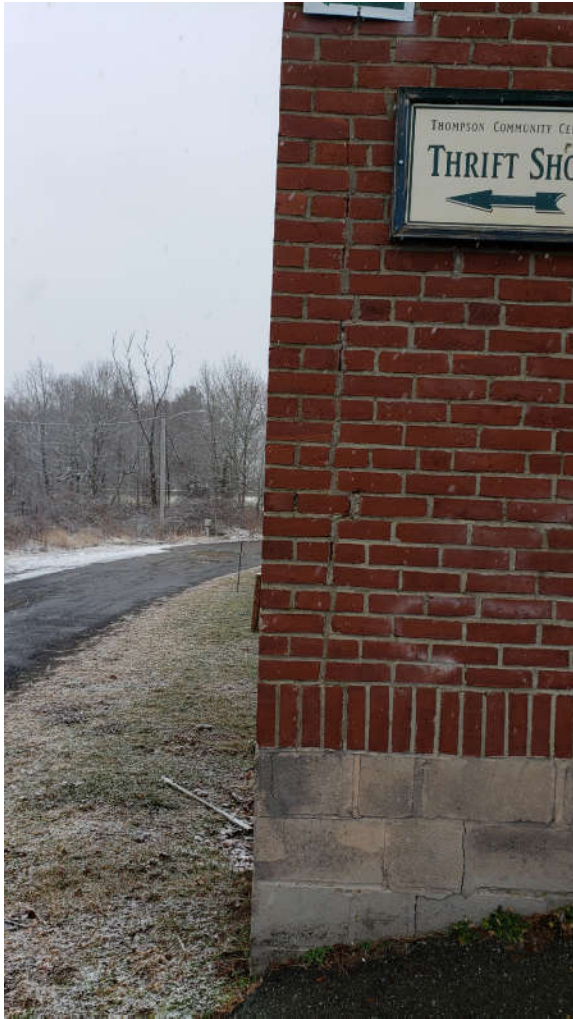
Photo 9 – Corner cracking 2023

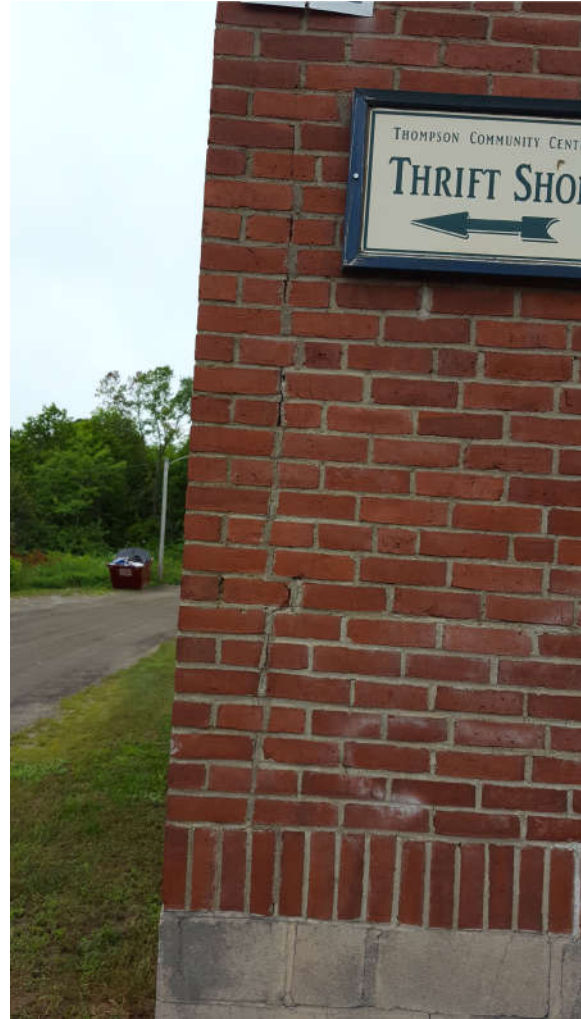
Photo 10 – Corner cracking 2018
